1.0 INTRODUCTION

WINDHAM SOUTHEAST SUPERVISORY UNION

INVESTMENT GRADE ENERGY AUDIT

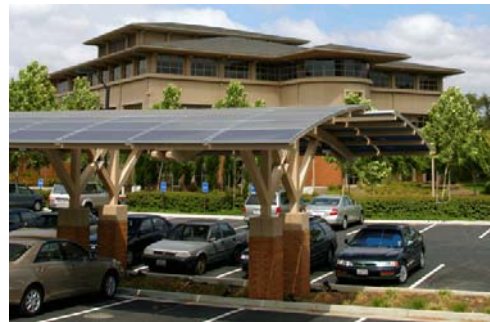
1. Solar Energy

Through this efficiency project, Brattleboro is reducing energy consumption. Now is the best time to introduce a solar electric (photovoltaic [PV]) system. The electricity produced by a PV system is used on-site resulting in reduced electricity demand from the utility. This provides valuable cost savings, especially during peak daytime periods, which is when solar systems produce the most electricity. Many of Brattleboro's accounts are currently on time of day (peak/off-peak) pricing. The more expensive peak hours will see the reduction, adding to the overall savings. Additionally, energy prices are volatile and will rise over the long-term. As rates rise, a PV system provides increased savings. Furthermore, Federal government incentives are available through rebates and incentives and can cover much of the cost of a solar electric system.

If implementing a PV system, Brattleboro would also be able to utilize monitoring equipment, both on-site and through a website, to illustrate and promote the clean renewable power being generated. Also, when Brattleboro is using less electricity than is being created at that moment, the system could charge batteries and provide backup power, or potentially sell power back to the grid through net-metering.

A feasibility study of adding a PV system to one or more school or municipal building roofs, or as a car shading structure, can be performed by American Energy Care with interest from Honeywell and Brattleboro.
